# Clean Air Act Compliance Inspection Report

### **Bristol Bay Fuels – Dillingham Terminal Dillingham, Alaska**

**Inspection Date: August 15, 2022**

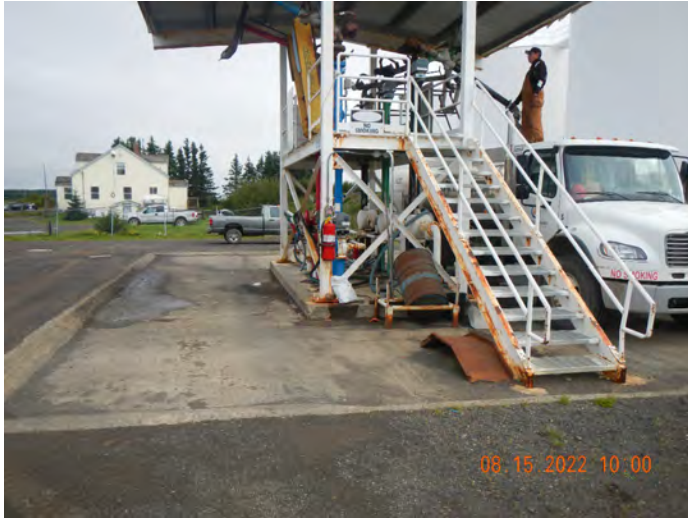
Photo #:01 (DSCN2665)

Description: Facing north, photo of the Facility's truck rack. A Facility truck was being filled via drop tube/downspout at the time of inspection.

At the time of inspection, one of the Facility's fuel trucks was in the process of being filled with Jet-A Fuel via a drop tube/downspout from above the tank (**Photo 1 & Photo 2**). The drop tube/downspout was inserted into the bottom of the tank for submerged filling. Fueling is operated by the driver of the truck.

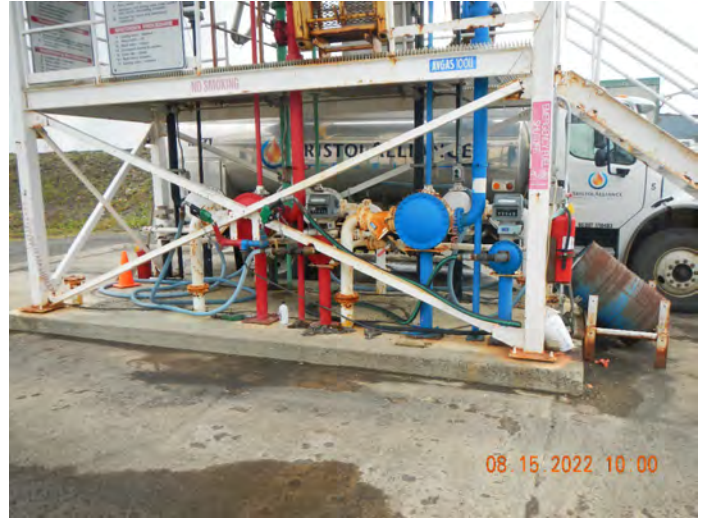
Photo #:02 (DSCN2666)

Description: Facing east, photo of the truck rack. Blue piping is used for AV gas, red piping is used for gasoline, black is used for fuel oil / jet, green is used for #2 diesel.

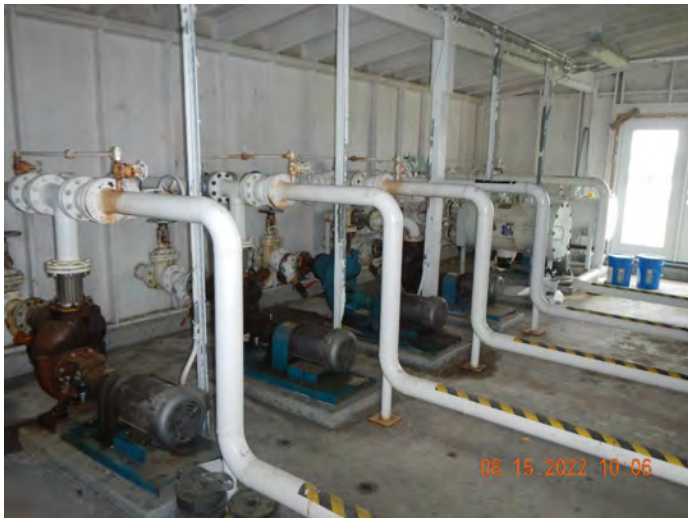
Photo #:03 (DSCN2667)

Description: Facing south, photo from inside the pump room. The pumps are utilized to distribute stored fuel from the tank farm to the truck rack.

We then toured the Facility's pump room (**Photo 3**); within the pump room a series pumps are used to supply fuel from the tank farm to the truck loading rack. Using the FLIR GF320 gas detection camera, no vapors/leaks were observed from the equipments gaskets/seals within the pump room (**Video 1**).

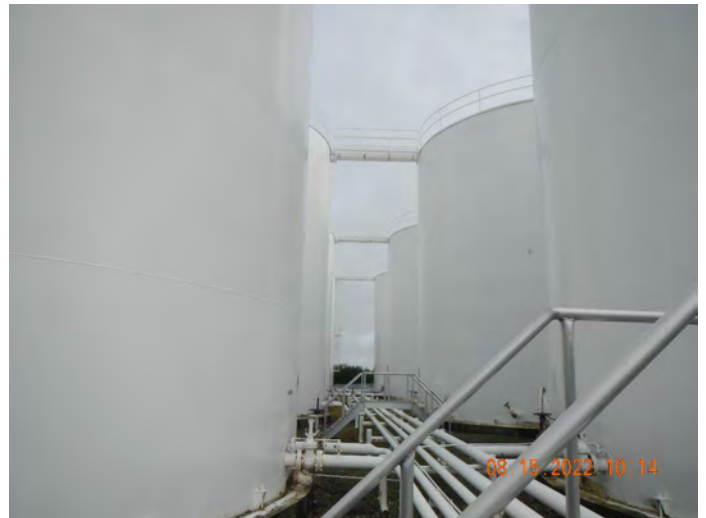
Photo #:04 (DSCN2668)

Description: Facing north, photo from within the tank farm.

We continued the tour to the Facility's tank farm (**Photo 4**). The tank farm was constructed with the Facility in 1996. The tank farm is diked and lined, there are eight vertical storage tanks: four 321,000-gallon tanks and four 414,000-gallon tanks. The tanks are welded steel with float type product level gauges, water draws, manholes, ladders and connecting bridges/walkways. Tank roofs are weak-seamed for emergency venting. According to Mr. Byrne, the tanks do not contain internal floating roofs. See below for tank number and associated product information:

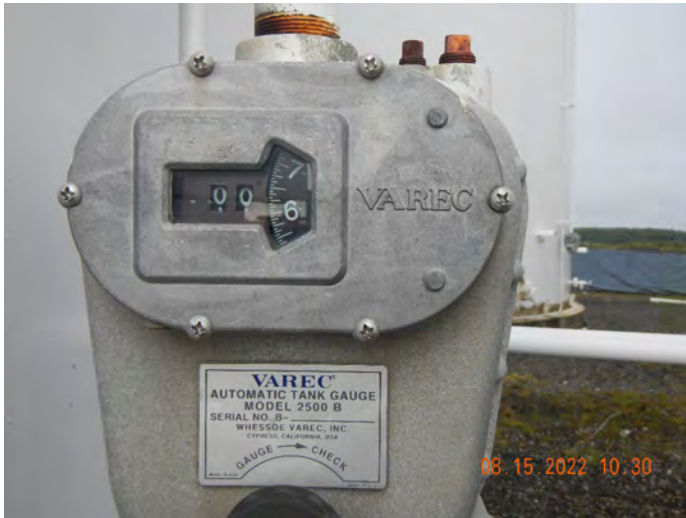
Photo #:05 (DSCN2669)

Description: Facing west, photo of the tank gauge at Tank #2 within the tank farm.

At the time of inspection, Mr. Byrne stated that Tank #2 and Tank #6 were considered “empty” with just a trace amount of product as indicated on each tank gauge (**Photo 5**). We first toured the tank farm from ground level, observing the gasket/seals (**Photo 6 & Photo 7**), each gasket/seal appeared to be in working order. I also observed the gaskets/seals on each tank using the FLIR GF320 gas detection camera, no vapors or leaks were observed (**Video 2 – Video 5**). According to Mr. Byrne these gasket/seals are routinely checked as part of daily operations and are also on a replacement/maintenance schedule. Mr. Byrne stated that typically brownish staining or a sheen below is indicative of a minor leak. As indicated earlier in this report, routine Facility inspections are documented on weekly and monthly checklists (**Attachment D**).

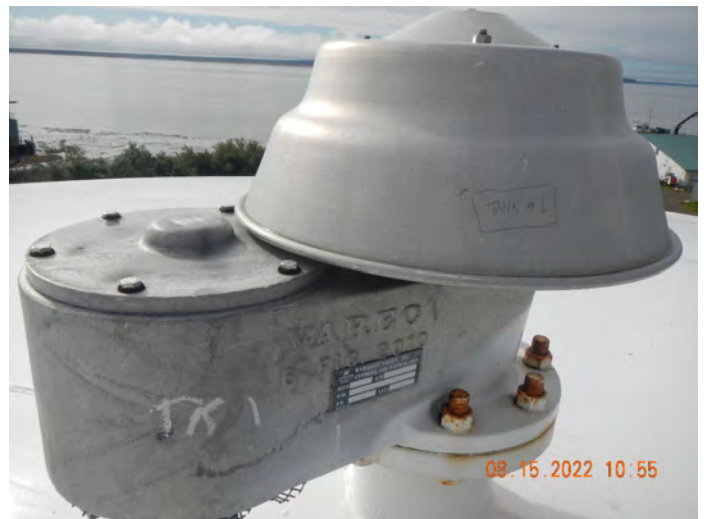
Photo #:08 (DSCN2672)

Description: Facing south, photo of VAREC® pressure relief valve located on the top of Tank #1 within the tank farm.

We then observed the top of the tanks via the connecting bridges/walkway above, this included observing pressure relief valves (**Photo 8 & Photo 9**) and vents. Pressure relief valves were installed on Tanks #1, #2, #4, #5, placards indicated that the valves were manufactured by Whessoe Varec, Inc. Each placard also included an identifying serial number. Tanks #3, #6, #7, #8 were not equipped with a pressure relief valve but what appeared to be a curved vent. Looking at the top of the tanks with the naked eye, I did not see any vapors. However, using the FLIR GF320 gas detection camera, vapors were observed coming from the vent/valve in each tank except for Tank #5 and Tank #7 (**Video 6 – Video 13**). Using the camera’s view finder, Mr. Byrne also viewed select vent/valves. Mr. Byrne was not aware of the valve’s current pressure release setting or any recent calibration and/or service. It was discussed that venting at Bulk Plants is not prohibited under Part 63 NESHAP Subpart BBBBBB.

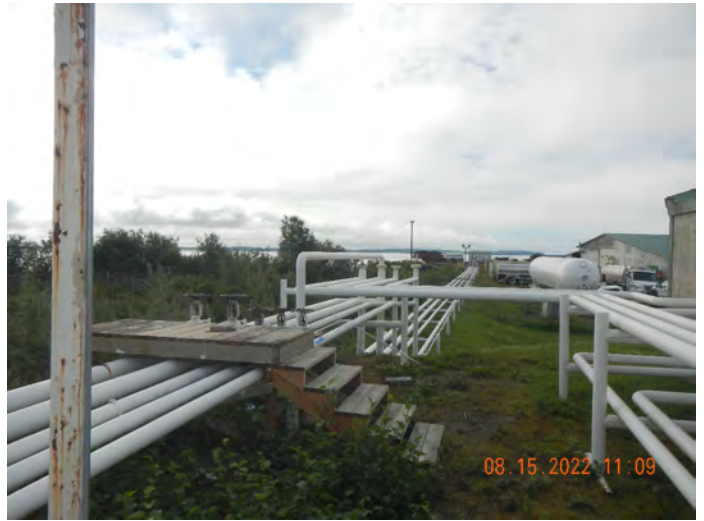
Photo #:10 (DSC2674)

Description: Facing south, photo of the “mid-line marine valves.”

After viewing each tank from above, we exited the tank farm and followed the marine service lines (**Photo 10**) from the tank farm in a southerly direction toward the marine loading rack. The marine service lines are located just east of the truck loading rack viewed earlier (**Photo 11**). We toured the marine cargo input location used to supply the Facility with product via barge (**Photo 12**), and then viewed the marine loading rack (**Photo 13**). The marine loading rack is used to provide fuel to the marine fishing vessels during the summer months/fishing season. Using the FLIR GF320 gas detection camera, no vapors/leaks were observed from the marine loading rack equipment (**Video 14**). We continued the tour by observing some of the vehicles used in the Facility’s fleet (**Photo 14 & Photo 15**). According to Mr. Byrne, a few of the vehicles/tanks are equipped with bottom fueling equipment but that the equipment isn’t used due to the fueling equipment at the truck loading rack. We concluded the tour back at the truck loading rack to further observe the drop tube/downspout equipment (**Photo 16**).

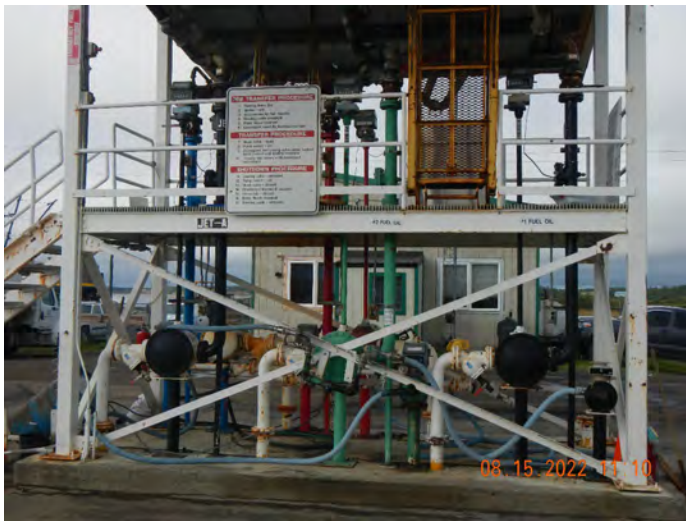
Photo #:11 (DSCN2675)

Description: Facing west, photo of the truck rack.

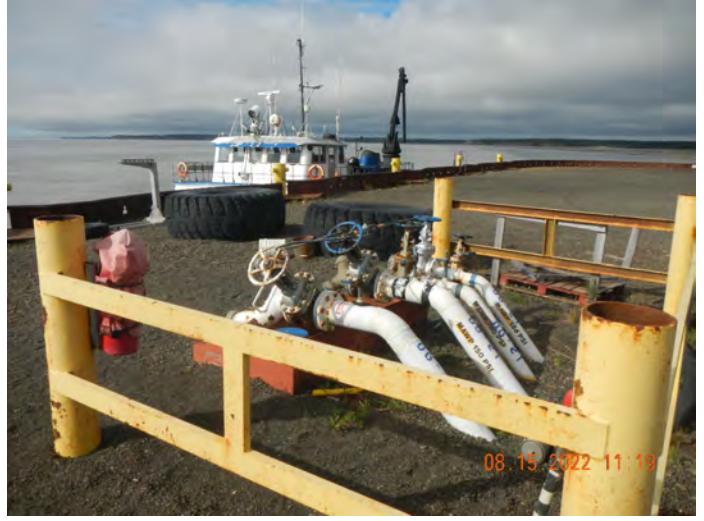
Photo #:12 (DSCN2676)

Description: Facing southwest, photo of the marine cargo input equipment.

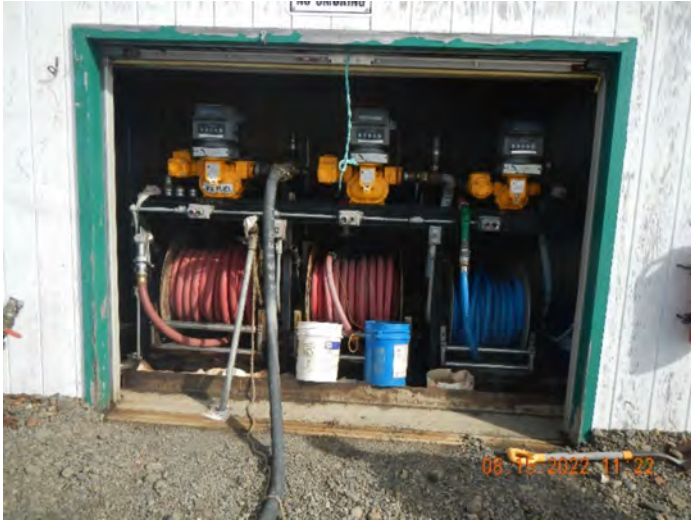
Photo #:13 (DSCN2677)  
Description: Facing north, photo of the marine loading rack.

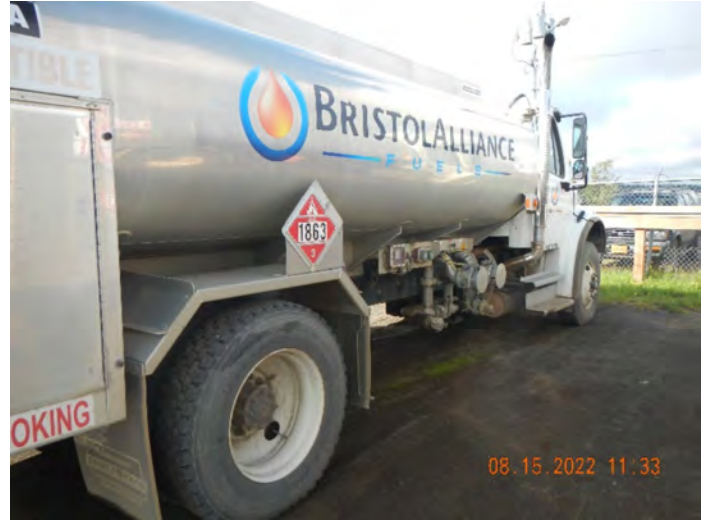
Photo #:14 (DSCN2678)  
Description: Facing southwest, photo of a tanker truck that is part of the Facility's fleet. According to Mr. Byrne, a portion of the trucks are equipped to be filled via bottom-fill.

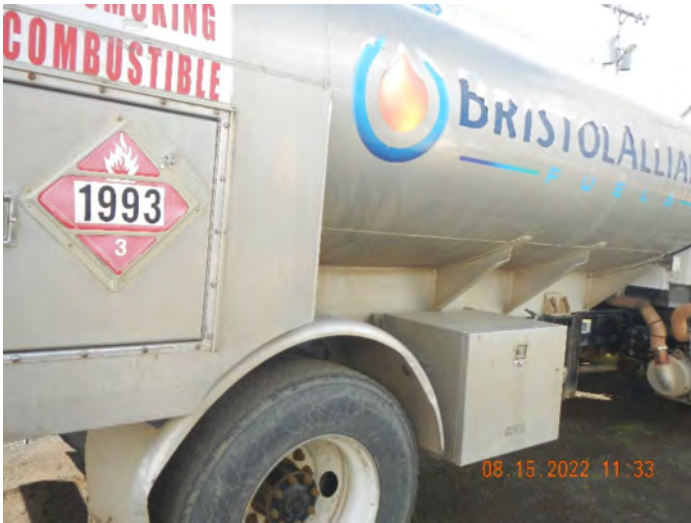
Photo #:15 (DSCN2679)  
Description: Photo of a tanker truck that is part of the Facility's fleet. According to Mr. Byrne, a portion of the trucks equipped to be filled via bottom-fill.

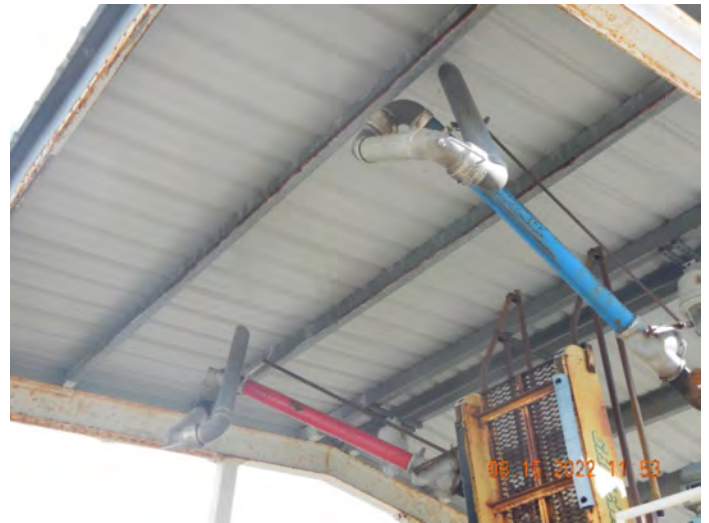
Photo #:16 (DSCN680)  
Description: Facing northeast, photo of two of the drop tubes/downspouts used at the truck loading rack.
